Manhole Inspection Summary

Manhole # S27A__026MH

Location Address: **REAR OF 725 DOLPHIN ST**

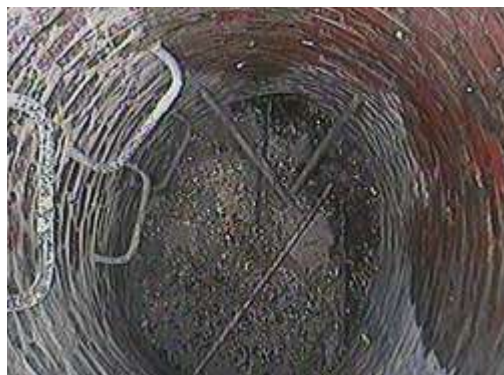
Top View

Comments **MULTIPLE RATS IDENTIFIED INSIDE MH.**

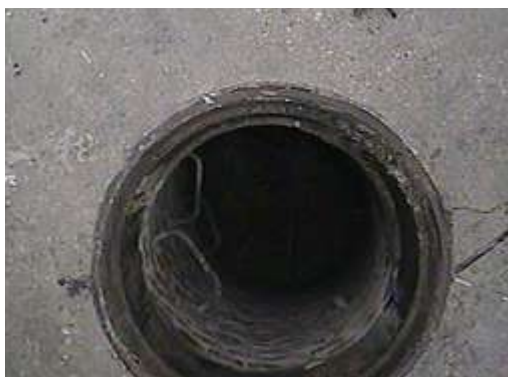
Top View

Condition: ☐ Sound ☐ Cracked ☐ Root Intrusion ☐ Deteriorated ☐ Leaks ☒ **Debris**

DEBRIS

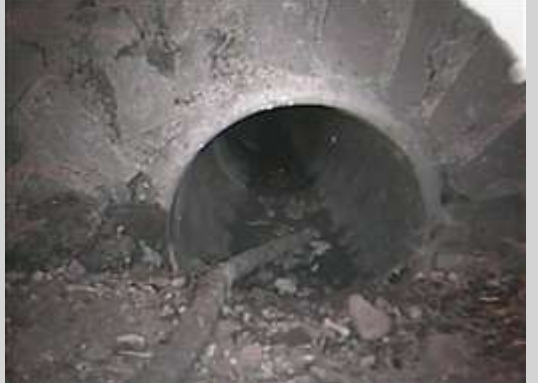
12 O'Clock Outflow

8 in. Circular Gravity Sewer
Pipe Out @ 12 O'Clock
